*Worldwide repairs carried out with PolymerMetal®*

**REP-# 066**

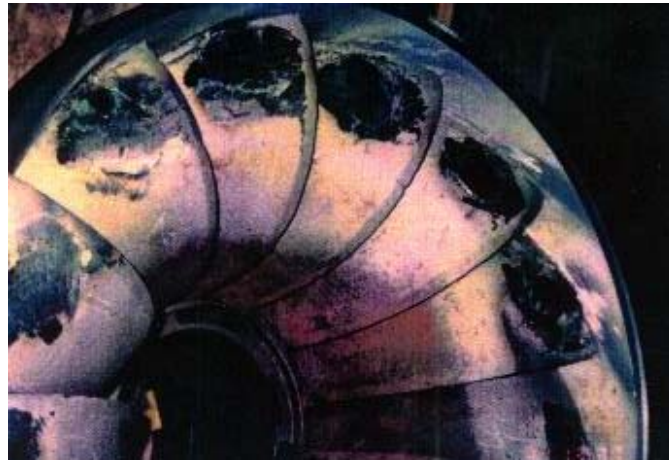
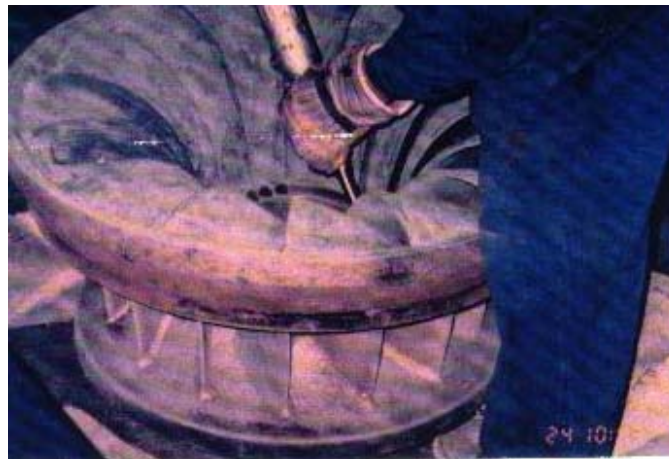
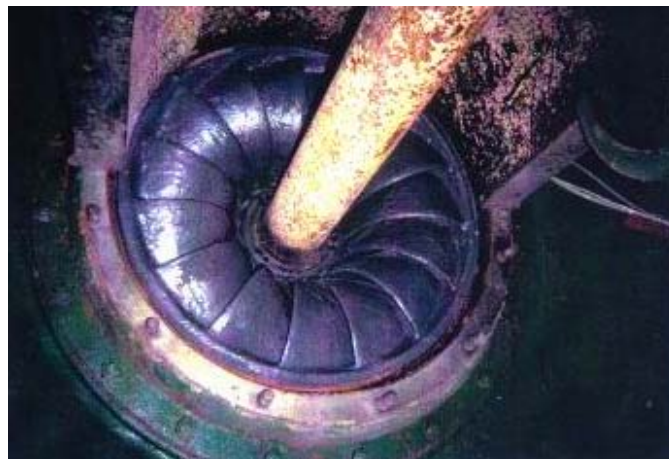
Repair of two turbine rotors. Damages were present at all areas of the blades where the water leaves the blades. First large holes have been welded. Then the erosive areas have been filled up with Ceramium, pasty. Finally a supplementary layer of VP 10-017 has been applied as protection against cavitation.
